PARALLELOGRAM SHAPED OPENINGS IN PRESTRESSED
CONCRETE TEE BEAMS

A THESIS

DEPARTMENT OF CIVIL ENGINEERING

FALL, 1971

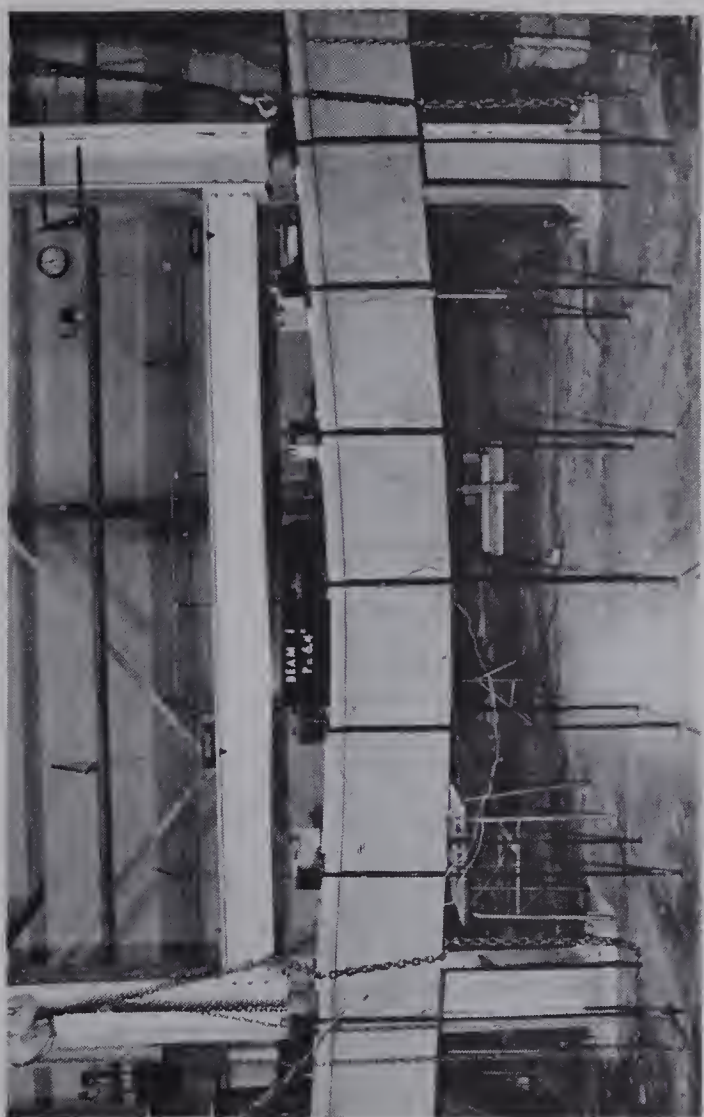
FIGURE 4.5(a) CRACKING AND FAILURE PATTERNS, BEAM 1

Beam 1 was designed and tested using a seven point loading. From its behavior during loading and up to failure, it can be said that it behaved as a typical under-reinforced prestressed tee beam. The cracking pattern can be seen from Figure 4.5(a). Cracking started mainly in the central portion of the beam and extended toward the end regions toward the latter stages of loading. At the ultimate load some of these cracks had reached the flange as is shown in Figure 4.5(a). However, none of the cracks opened up very wide, as two bars of #3 longitudinal reinforcement were placed all along the beam just below the four prestressing strands.

Shear reinforcement for this beam consisted of inclined stirrups spaced at 15 inches, all along the supported span. From the shear design calculations, inclined stirrups were required at a very large spacing (see Appendix C). A minimum spacing of $0.75 \times \text{depth}$ is required for vertical stirrups in the ACI Code¹. This minimum value is 15 inches, and was also used in this beam as a minimum requirement for inclined stirrups. Some cracks opened up along the length of these stirrups toward the final loading stages (see Figure 4.5(a)).

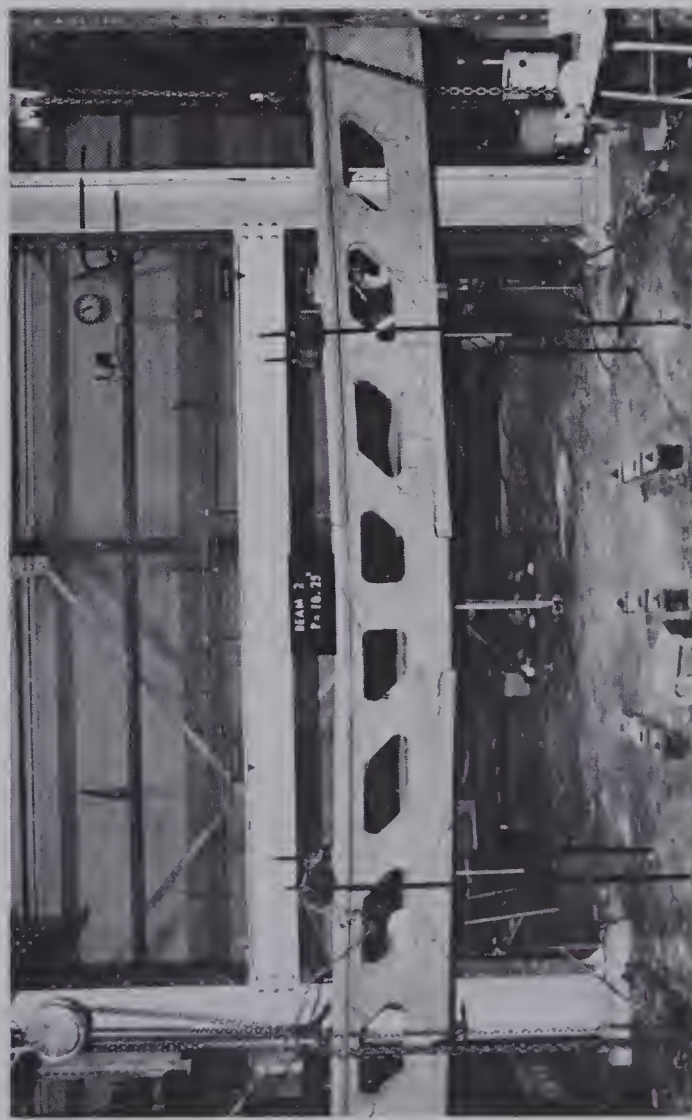
FIGURE 4.5(b) CRACKING AND FAILURE PATTERNS, BEAM 2

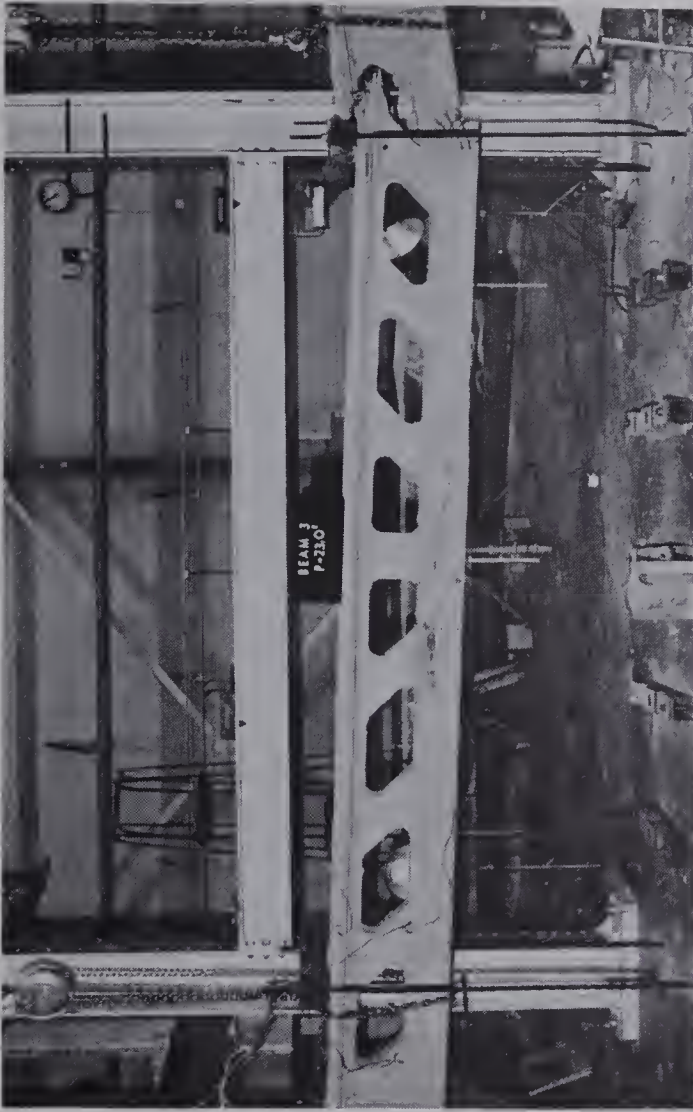
FIGURE 4.5(c) CRACKING AND FAILURE PATTERNS, BEAM 3

Load group 4 consisted of Beam 3. This beam was alone in its group because it was tested under severe shear conditions, that is, two point loading was used spaced at 12 feet centers. Failure occurred through the outside hole on the right hand side next to the load point, as shown in Figure 4.5(c).

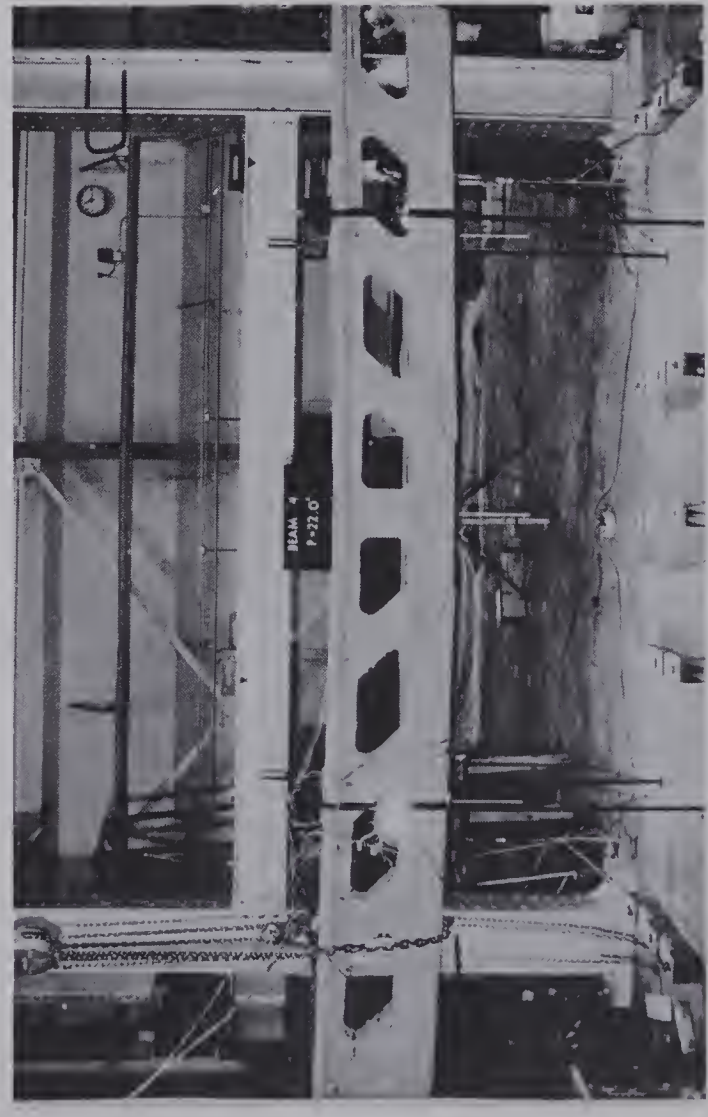
FIGURE 4.5(d) CRACKING AND FAILURE PATTERNS, BEAM 4

Load group 3 consisted of Beams 2, 4 and 9. This group all had two point loading, spaced at 8 feet centers and all had 8 parallelogram shaped openings. Beams 2 and 9 contained 4 strands, while Beam 4 contained 5 strands. Beams 2 and 9 were identically designed and tested, except that Beam 2 had less shear reinforcing than Beam 9. Beam 4 which contained 5 strands, had much more shear reinforcing than either of Beams 2 or 9, as shown in Figure 3.4. A flexural failure by rupturing of the strands occurred for Beams 2 and 9, however, for Beam 4 due to the higher flexural strength and therefore higher shear stresses approaching the flexural capacity of the beam, the beam failed in shear through the first hole to the right of the right hand load point. An explosive type of failure resulted (see Figure 4.5(d)).

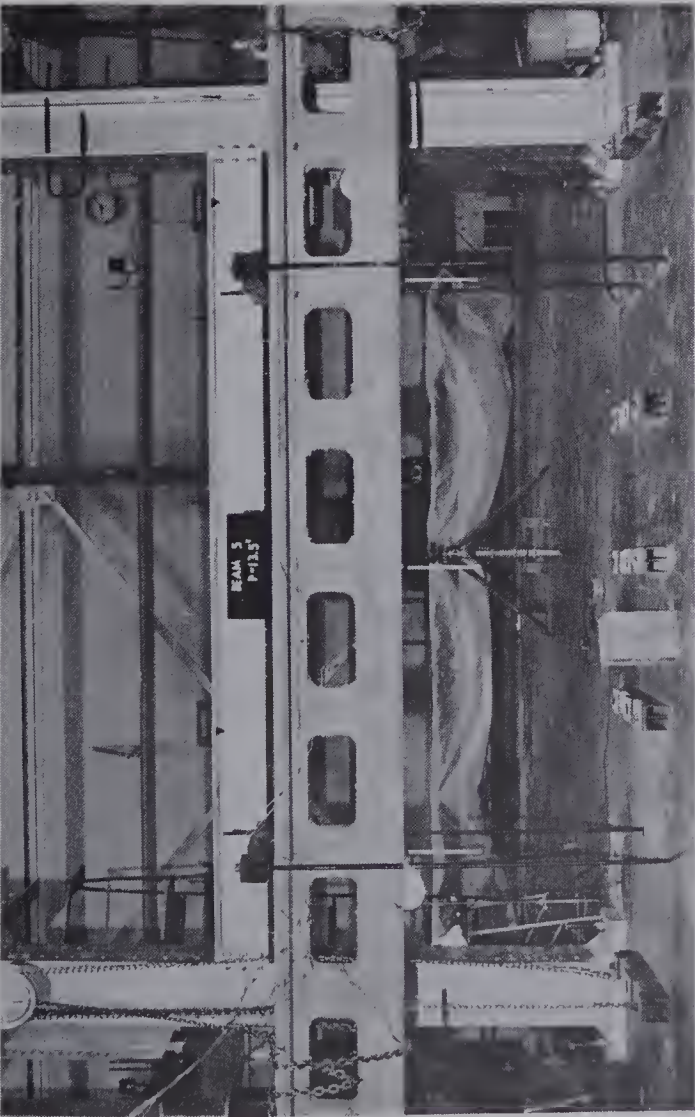
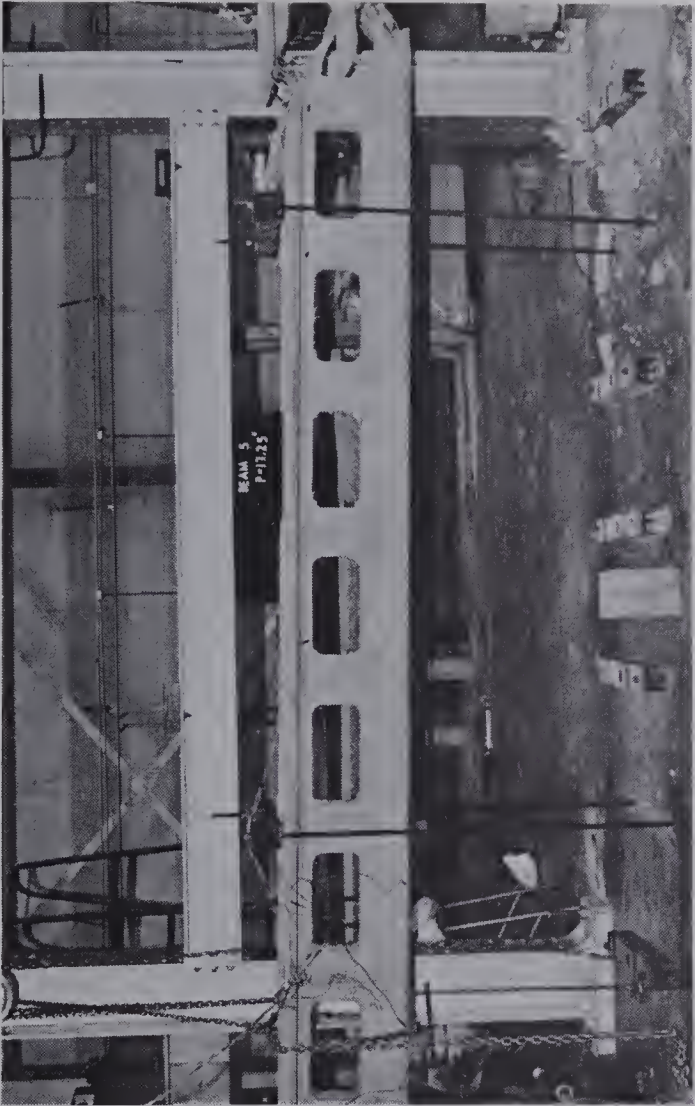
FIGURE 4.5(e) CRACKING AND FAILURE PATTERNS, BEAM 5

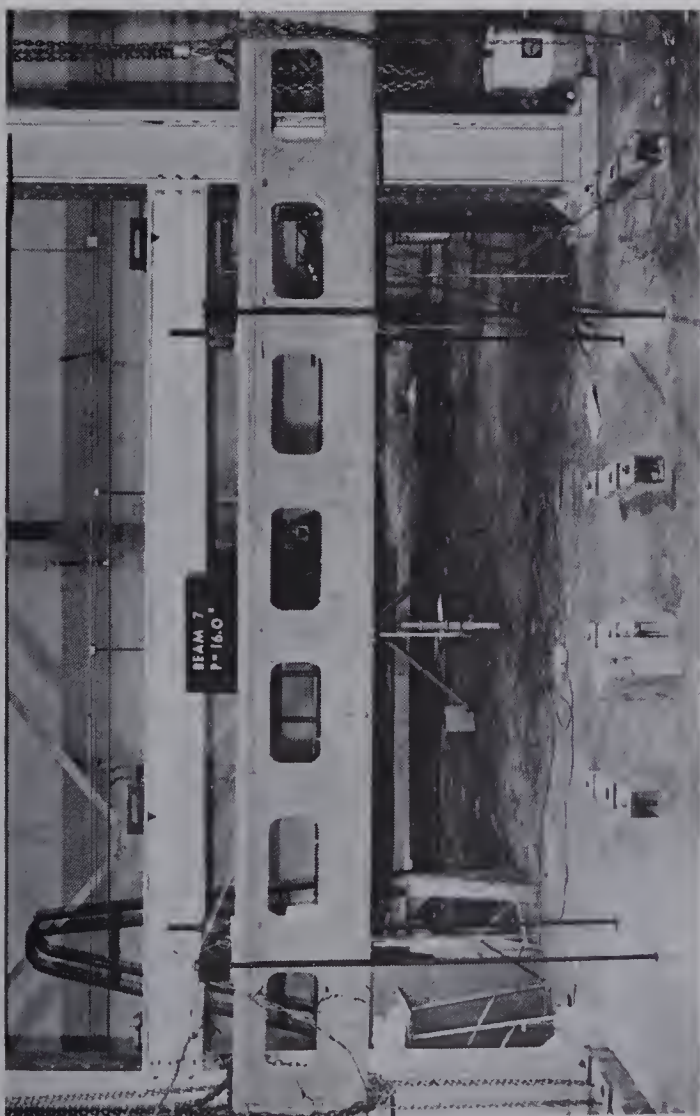
FIGURE 4.5(g) CRACKING AND FAILURE PATTERNS, BEAM 7

location (see Figure 4.5(f)). This gave a total hole area of 747 in^2 for 6 rectangular openings, compared to 996 in^2 for 8 rectangular openings. Beam 7 failed in shear in almost the same manner as did Beams 5 and 6, however, due to the addition of supplementary shear reinforcing in the lower web, a more ductile type of shear failure occurred (see Figure 4.5(g)).

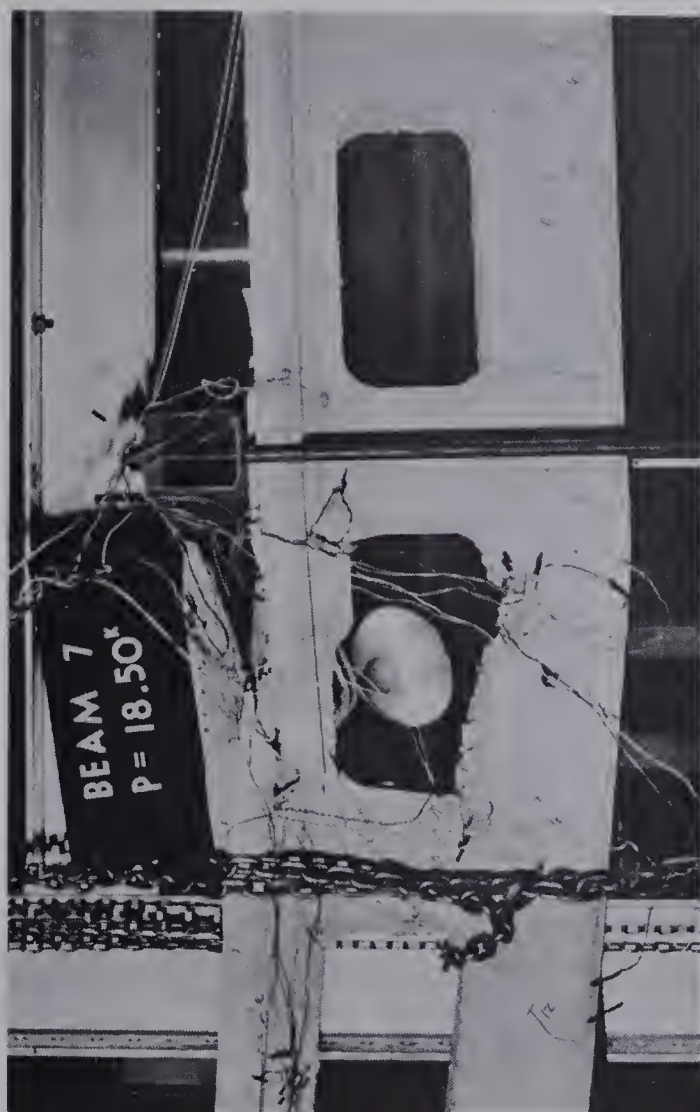
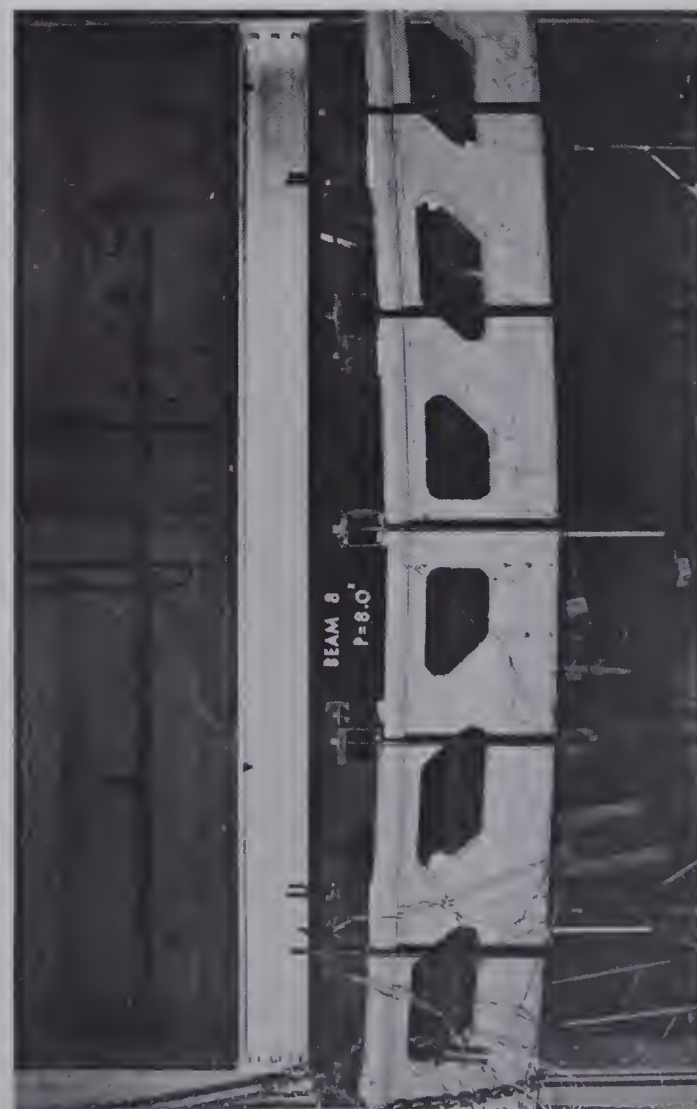
FIGURE 4.5(h) CRACKING AND FAILURE PATTERNS, BEAM 8
